By Stephen Martin

## Geotextile Tubes Provide Coastal Erosion Protection in Ecuador

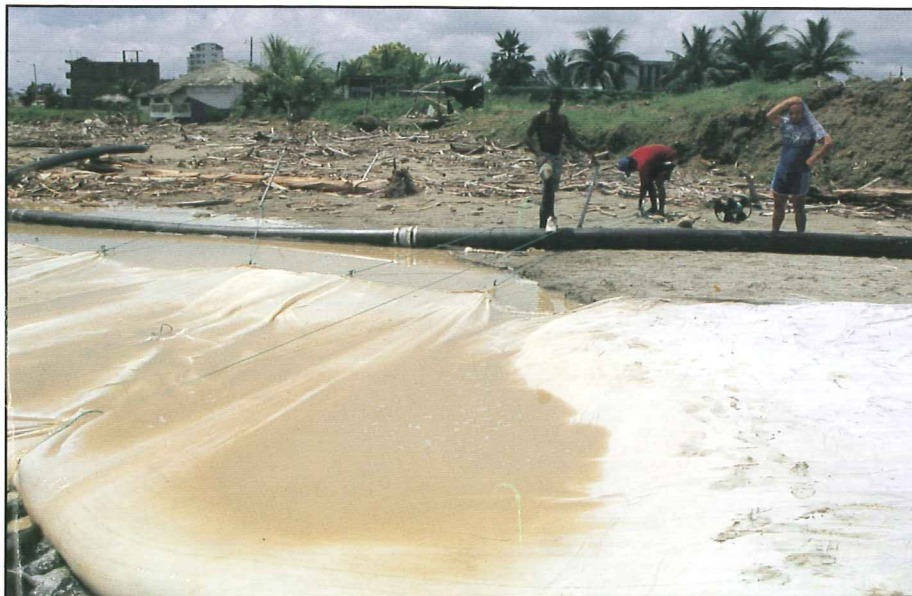
The project began with the installation of a Geotex 4x6 PP tube, 4.6 m (15 ft.) in circumference and 50 m (164 ft.) in length. It was placed along the riverbank to redirect the riv-

er's flow away from the foundation of a hotel and downstream residences.

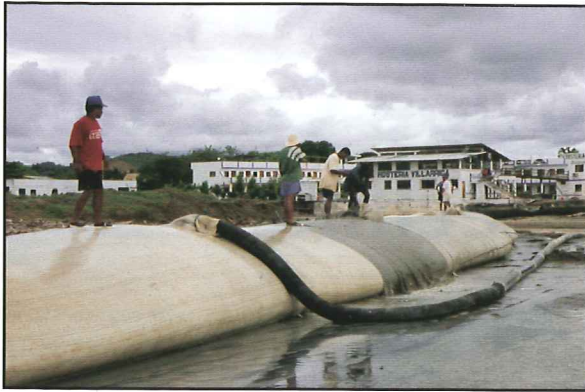
The Geotex 10x10 tubes, 9.2 m (30 ft.) in circumference, were placed along the opposite riverbank, extending forth along the beach to absorb the energy of the El Niño-generated storm surge. Five 100-m (328-ft.) tubes were installed end to end for a total length of 500 m (1,640 ft.). The tubes will not only absorb energy from the storm surge, but will also allow beach sand to naturally be deposited behind the tubes, restoring the beach.
