## **Envirotubes**<sup>™</sup>

A Case Study by Industrial Fabrics, Inc.

## LOUISVILLE GAS & ELECTRIC COMPANY SLUDGE PONDS OVERFLOW

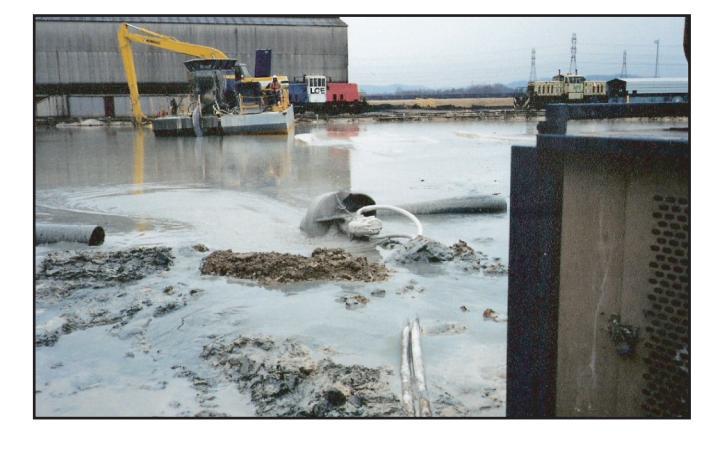
The sludge, which consisted mostly of lime and gypsum, was being cleaned from the ponds with a long reach excavator, spread out to dry, and hauled to a landfill. This process was not keeping up with the input rate of solids, the excavator was too slow and there was not enough room to dry the sludge. The sludge could not be landfilled without dewatering. If something was not done the plant would have to shut down.

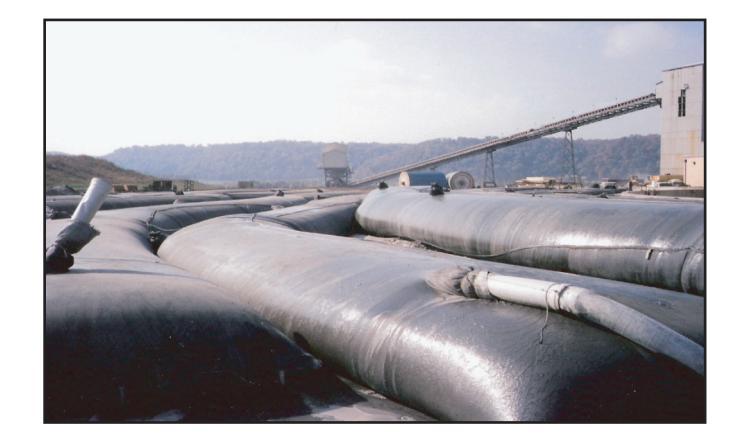
Working together with Midwest Dredge, we did a test, pumping with dredge into a 30 ft. circumference x 50 ft. long tube. The test went well and the plant hired Midwest Dredge to pump the sludge from the ponds to the tubes for dewatering. By the end of the first full day of pumping the plant was out of trouble. The project engineer informed us that the whole clean up was costing much less than he had anticipated. All three ponds were emptied into the tubes, dewatered and hauled to the landfill without a mishap. The tubes were 30 ft. circumference x 200 ft. long made of 4x6 geotextile fabric. Each tube was pumped several times as it dewatered, and where stacked on top of each other to conserve space.
